THE HISTORIC VEGETATION OF FORT BIJ VECHTEN EXCURSION NOVEMBER 25TH, 2009

The development of military vegetation on the Nieuwe Hollandse Waterlinie

The military vegetation of Fort bij Vechten

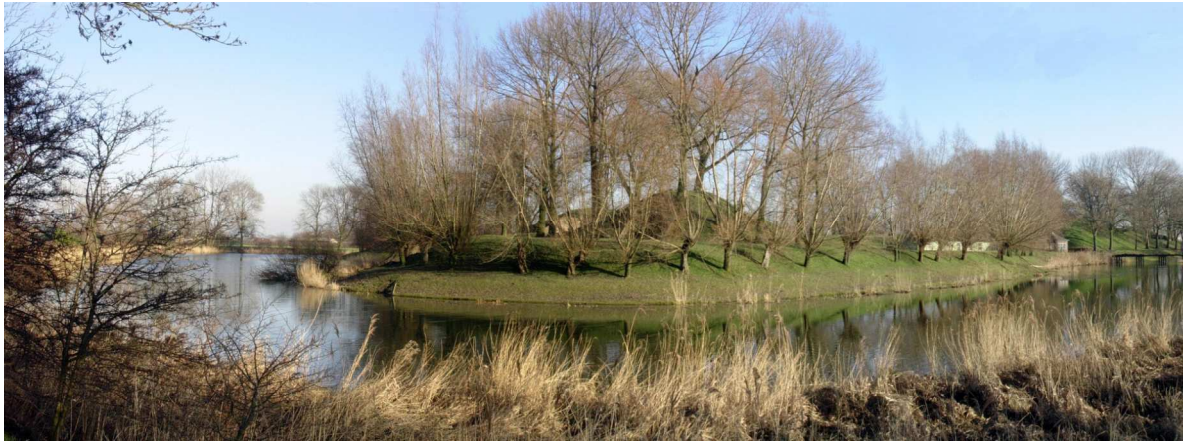
Figure 2 – Pollard willow of Fort Nieuwe Steeg. Pollard willow provided camouflage and cover.
 (Picture : Bureau SLA)

Second, trees and shrubs were used to provide camouflage and cover. For this purpose especially pollard willow was planted. The crowns of pollard willow created enough camouflage to conceal the guns on the fortification whereas the thin, flexible branches did not hinder the defensive fire from these guns. Also tree species like elm (*Ulmus spp.*), poplar (*Populus canescens*, *Populus x Canadensis*, *Populus spp.*) and Norway spruce (*Picea abies*) were used for camouflaging the fortifications in the landscape and providing cover and camouflage for the defenders on the fortifications.

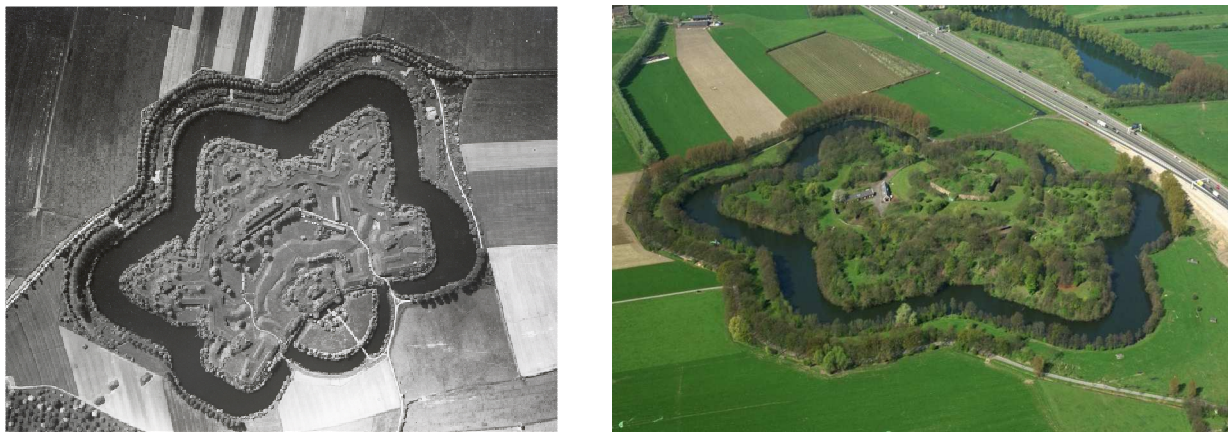
Figure 4 – Aerial photographs of Fort bij Vechten in 1926 (left) and 1997 (right)

Fort bij Vechten is a fortification of 17 ha. It was built between 1867 and 1870. Initially the fortress was covered with grass sods. Spots that were not suitable for applying sods were sown with ryegrass (*Lolium spp.*). In 1879 the War Office gave orders to establish defensive vegetation on the fortress. In 1880 specifications were made to plant 15 sycamore trees, 15 common horse chestnuts (*Aesculus hippocastanum*), 15 red oaks (*Quercus rubra*) and 15 lime trees (*Tilia spp.*) on the inside of the fortress (Terre-plein). On the banks 400 white willows and 8000 thorn-bushes for hedges were planted. The specifications also included the planting of 13.000 sycamore trees for coppicing and 50 elm trees on the glacis. The access road was planted with 250 oaks. In the next years 1892 and 1899 several specifications were made for the maintenance of this vegetation. These specifications show that in 1899 the fortress contained 2.2 hectares of coppice, 1250 meters of hedges, 13.114 metres of coppice on banks and slopes, 387 old trees and 165 young trees. An inventory made in 1909, showed that the defensive vegetation was still intact. However, aerial photographs taken in 1926 show that part of the defensive vegetation has been cleared, this was presumably done during the mobilization in World War I.
